The Sundew

Cumbrian Bogs LIFE project newsletter

Our new National Nature Reserve: Bolton Fell and Walton Mosses

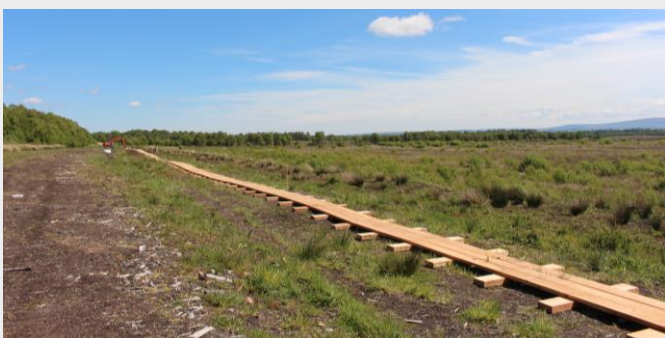
Simple floating boardwalk installed at Bolton Fell Moss © Natural England

Our project staff are keen to respect the wishes for a wider boardwalk. Unfortunately, the newly re-wetted peat body is unstable, and the peat surface will continue to settle for several years before it is possible to install this type of boardwalk. In the short-term, safe access will be provided to part of the site using a floating, 3-plank boardwalk. It will take visitors 1.5 km from the viewing platform at the edge of the factory site to the central woodland.

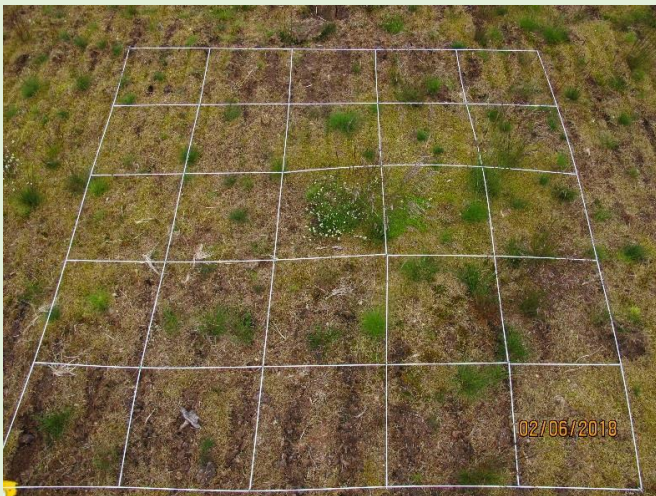
Prior to revegetation, square frames called quadrats, measuring 2 x 2 meters and split into 25 cells, were distributed at randomly generated GPS points on the site and all species recorded. The percentage of bare peat was also recorded and each quadrat photographed.

Example of quadrat used for vegetation survey © Natural England

Recent findings suggest that after 2 years of restoration, Sphagnum moss cover increased by 6%, and bare peat cover was reduced from 87% to 49%.

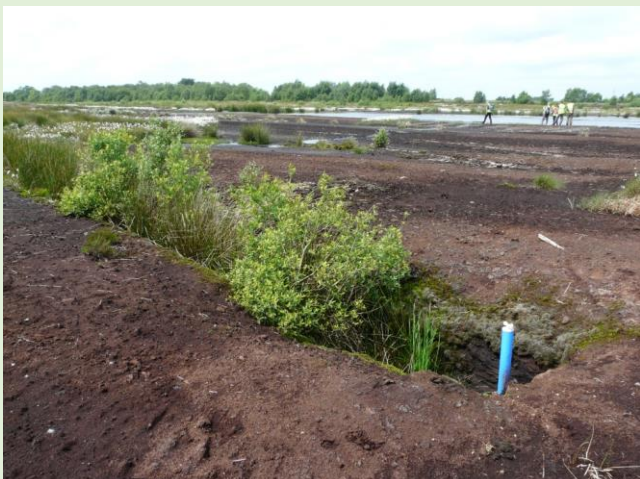
Dipwells are used to measure the water table (level of water underground). The blue tubes sit vertically to the peat and have small holes which allow them to fill with water and which can then be measured. Good water levels for restoration generally stay within 10 cm of the surface.

Example of a dipwell at Bolton Fell Moss ©Natural England

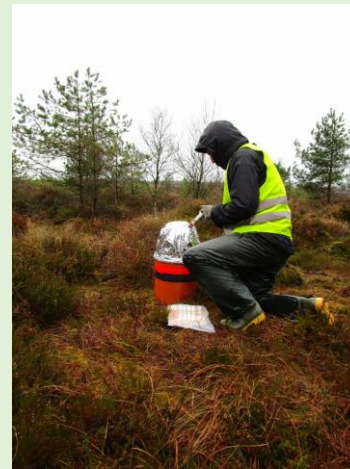
The 'static chamber method' was used to measure carbon dioxide, methane and nitrous oxide levels. The lids of the chambers were covered with reflective material to reduce heating of the headspace. Gas was collected through a rubber septum using a syringe. After 2 years of restoration work, it is possible

Greenhouse gas measurement © NE

to model the carbon fluxes and see they are converting from source (peatbog giving off carbon into the atmosphere) to sink (peatbog capturing and holding carbon).
